### **Building techniques under review**

#### Senior researcher, PhD-student Cecilie Flyen Øyen

Insuring future climate change 3. – 4. November 2008, Oslo

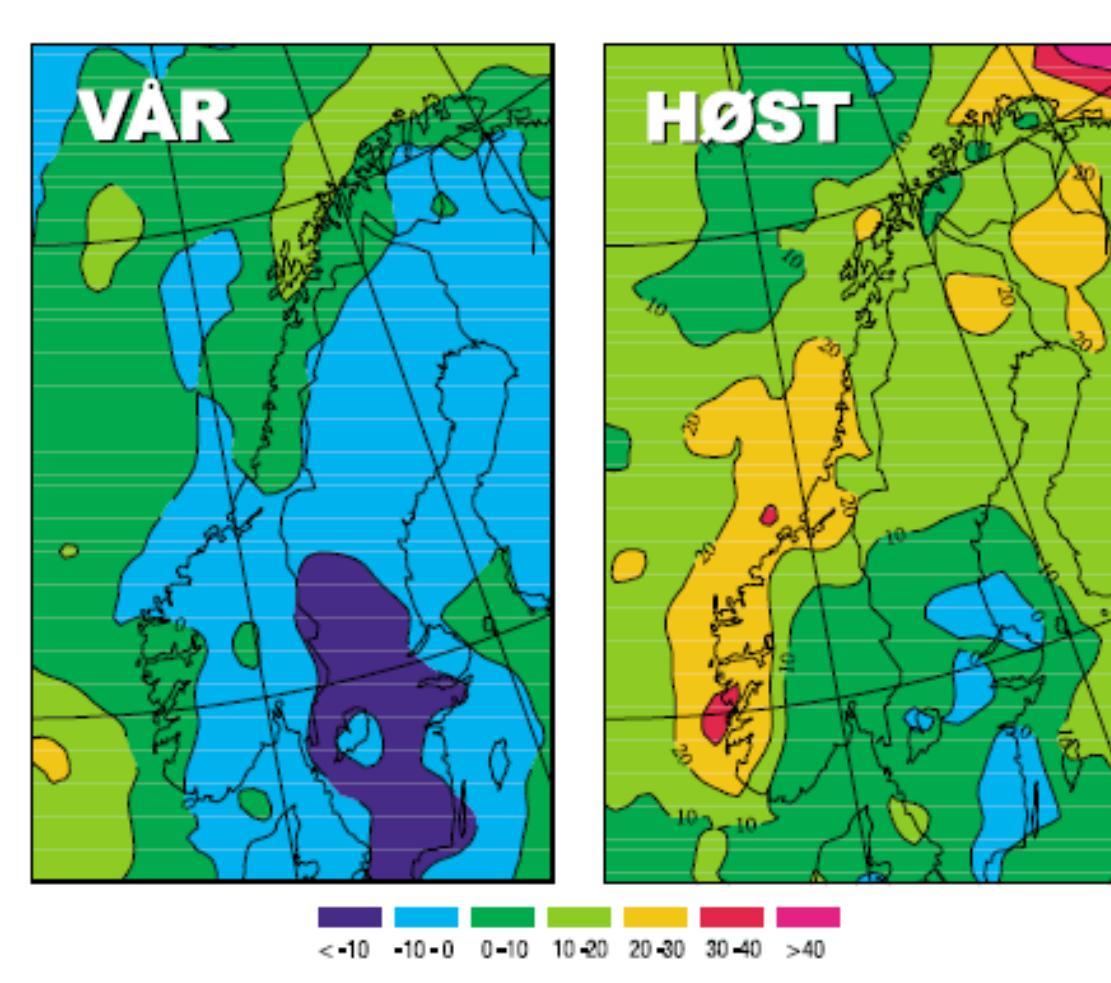
### Scenario: Changes in precipitation 2000 > 2050

Beregnet endring fra 2000 til 2050 av nedbør i %.

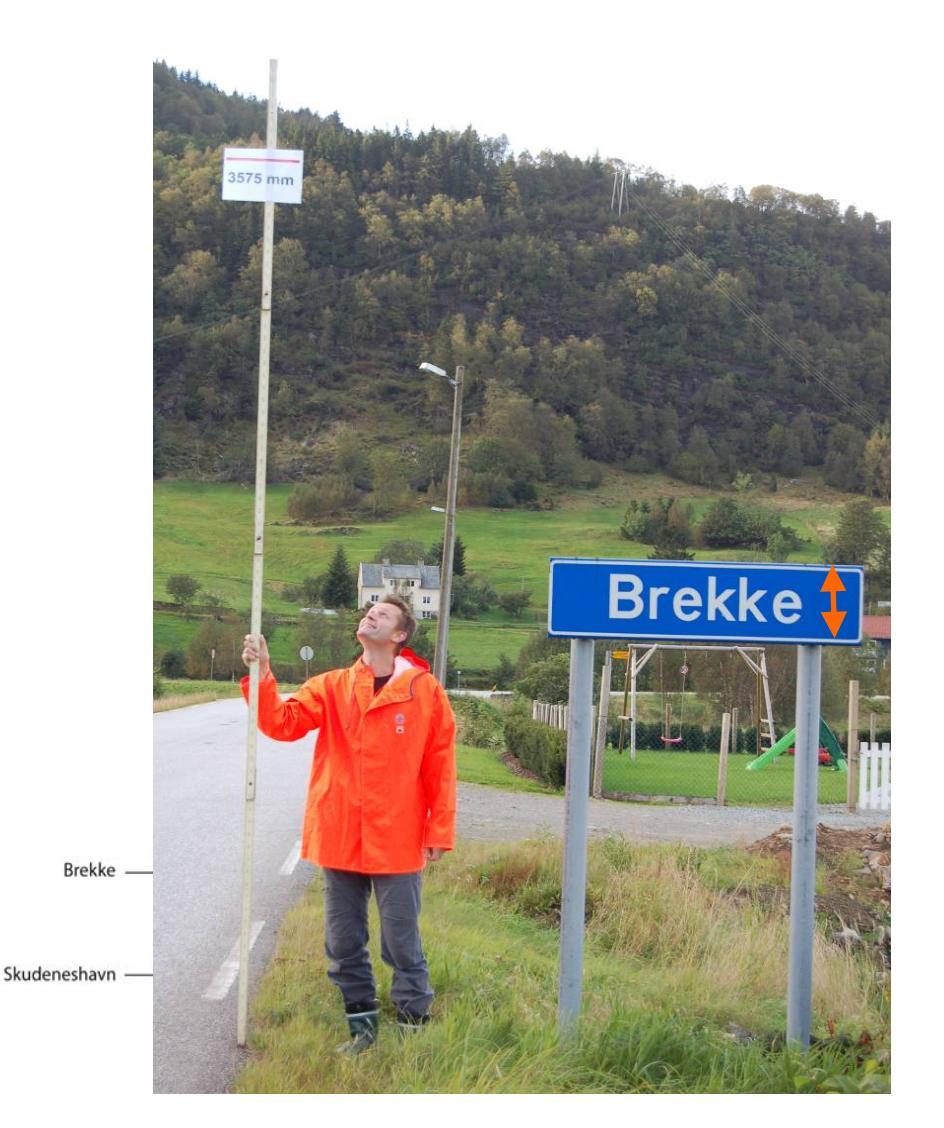
Mean annual precipitation: More than 3,5 meter: Along the Western coast (Sogn & Fjordane and Hordaland)

Largest amount of precipitation in 24h : 206.0 mm, Grøndalen (Western coast/Sogn & Fjordane)

Less than 300 mm: In the Central Eastern (Oppland) and Central Northern Norway (Nordland, Troms og Finnmark)

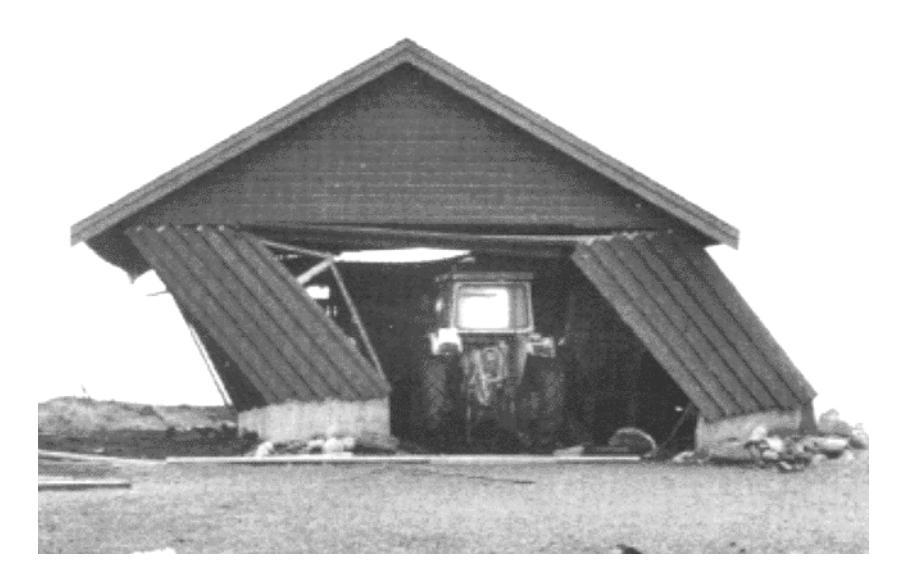
Damage due to insufficient static system. Photo: Kjell Langmyren (Building detail sheet Property management - 720.550)
